Document Number: 24-HL-UT-0152 (R9) / H72658 (Rev A)
Date: March 24, 2025
Classification: External
Attention: All OneWeb Customers
Related Products: HL1100W
Subject: HL-Fixed-1.0.62.1A Release bulletin

This release bulletin pertains to software release bundle HL-Fixed-1.0.62.1A for Hughes LEO Electronic Steering Antenna model *HL1100W*, grouped under model type *HL-Fixed* developed by Hughes Network Systems (HNS).

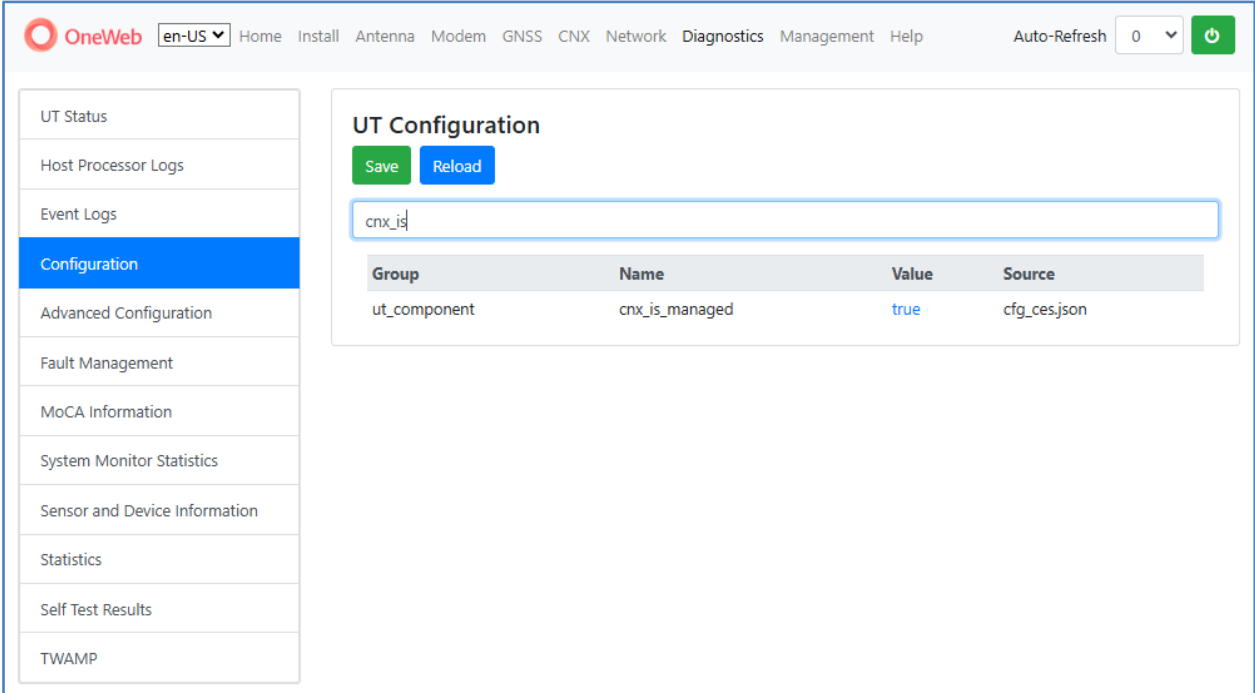
2. Verify CNX Managed Setting:

Upgrading firmware on a UT with a non-default ODU IP address configuration requires additional steps. Please refer to Appendix section 8.1

- Ensure the **CNX Managed** setting is set to **True**.
- Refer to the screenshot below to identify the fields to check.

- If it is not set to **True**, click on the value, select **Delete**, and save the changes. This will reset the configuration to **True**.
- Reboot the UT.
