Document Number: 24-HL-UT-0152 (R10) / H71410 (Rev H)
Date: May 23, 2025
Classification: External
Attention: All OneWeb Customers
Related Products: HL1120W
Subject: HL-Fixed-1.0.60.4A Release bulletin

This release bulletin pertains to software release bundle HL-Fixed-1.0.60.4A for Hughes Leo Electronic Steering Antenna model *HL1120W*, grouped under model type *HL-Fixed* developed by Hughes Network Systems (HNS).

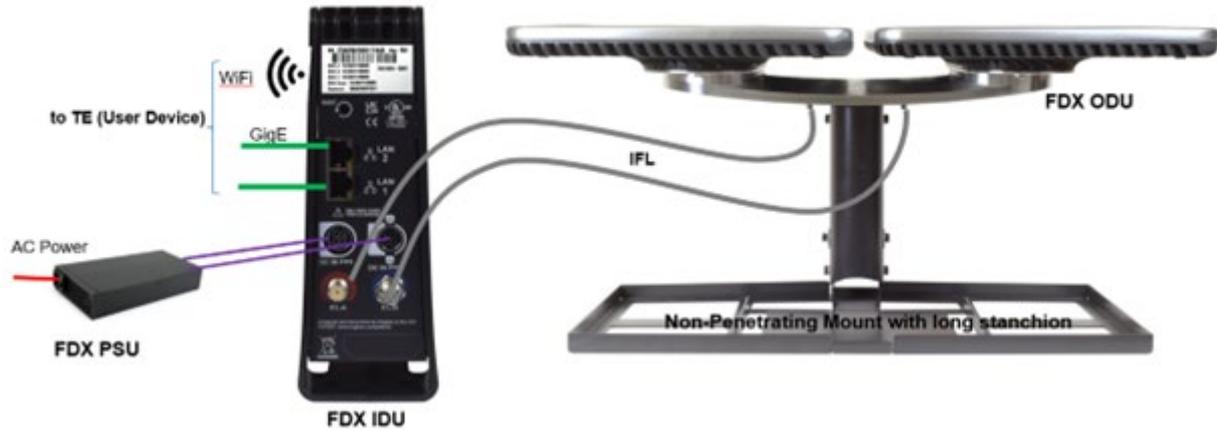
The HL1120W UT consists of three field replaceable units – outdoor unit (ODU), indoor unit (IDU), and power supply unit (PSU). The FDX ODU is installed outdoors on a mount, while the FDX IDU and PSU are installed indoors. **Figure 1** shows the HL1120W user terminal fully assembled.

Figure 1. HL1120W User Terminal

- Outdoor Equipment:
 - HL1120-ODU: The FDX ODU antenna assembly consists of two electronically steered antenna panels – the FDX-A panel for the receive (Rx) path and the FDX-B panel for the transmit (Tx) path. Each antenna panel has a Common Control Module (CCM), RF Conversion Module (RCM), and Beam Former Array (BFA). The CCM-A has a host processor that runs the UT software for control, Management, and network services. The CCM-A also houses a satellite modem that communicates with the OneWeb ground network through the OneWeb LEO satellites using the Rx & Tx tracking antennas.

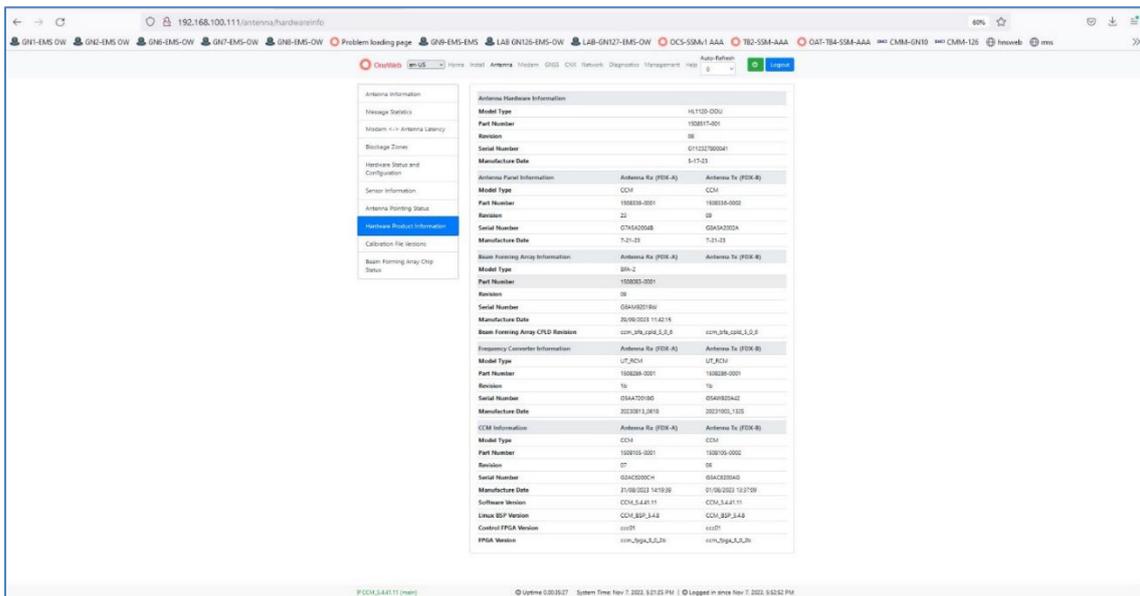
Login to the CCM LUI at <http://192.168.100.1>, and navigate to the *Antenna* → *Hardware Product Information* link to view HW information for the FDX antenna, two FDX-A/B antenna panels, and their BFA, RCM, and CCM modules.

Figure 2. HL1120-ODU Hardware Information

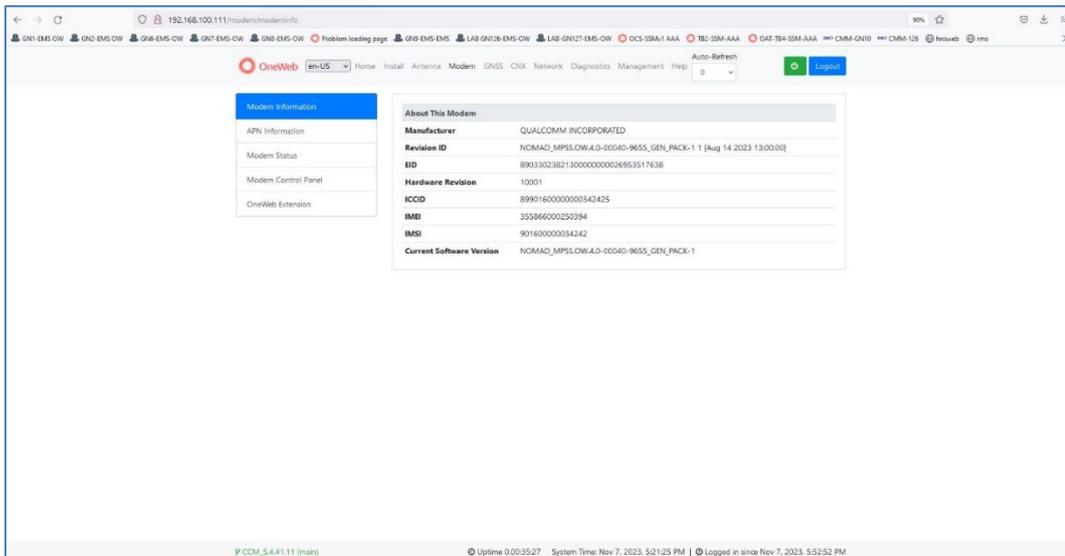
Navigate to the *Modem* → *Modem Information* link to determine modem information:

Figure 3. HL1120-ODU Modem Information

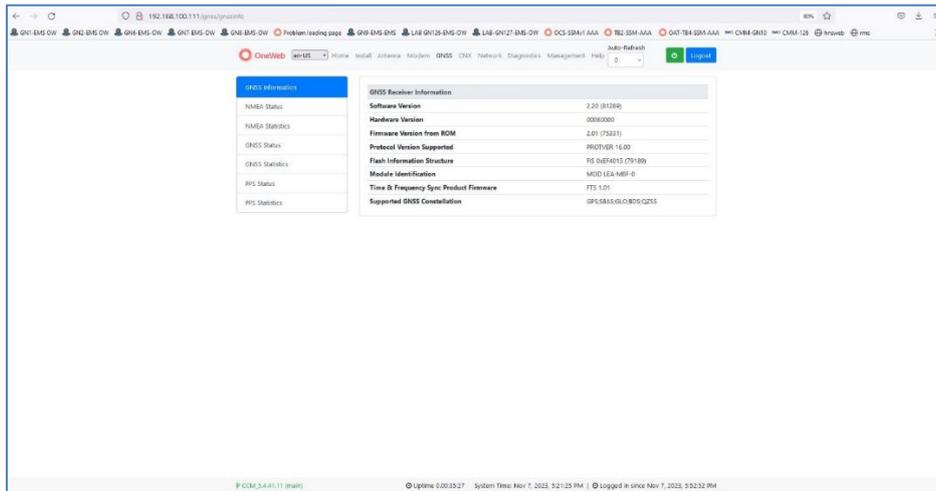
Navigate to the *GNSS* → *GNSS Information* link to determine OGR information:

Figure 4. HL1120-ODU OGR Information

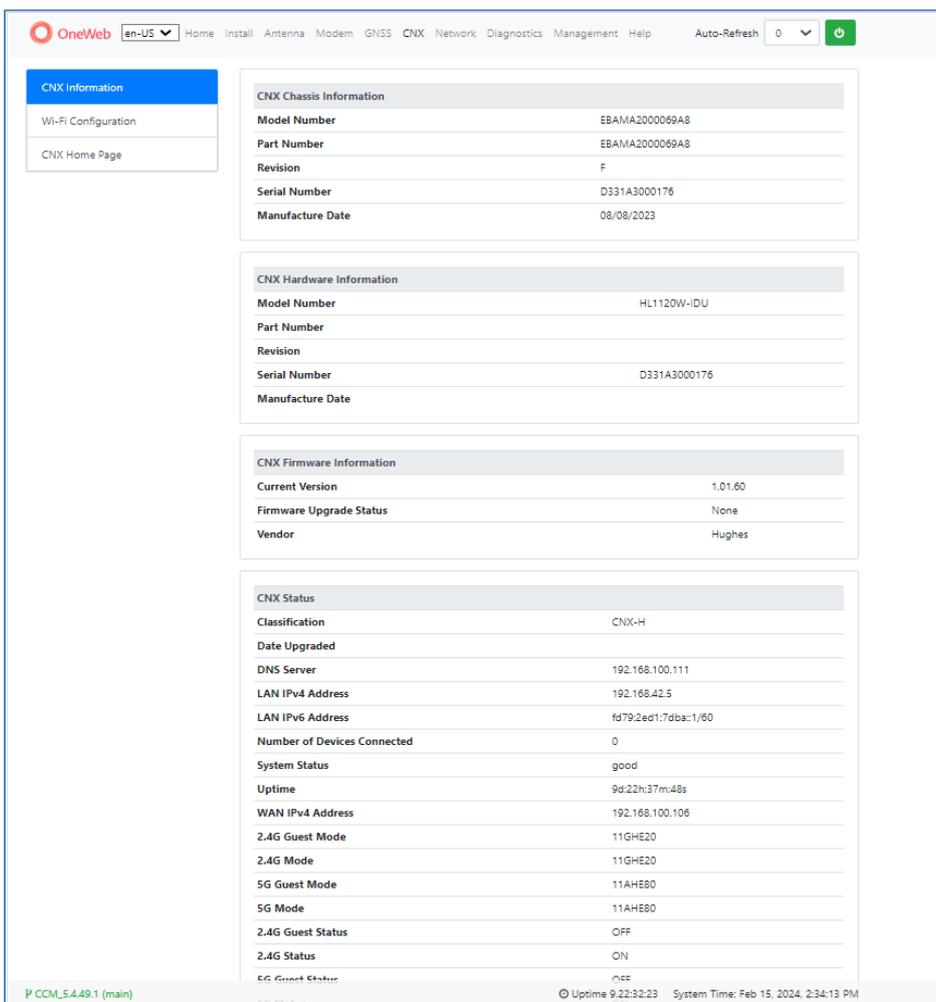
Navigate to the *CNX* → *CNX Information* link to determine IDU information:

Figure 5. HL1120W-IDU (CNX-H) Information

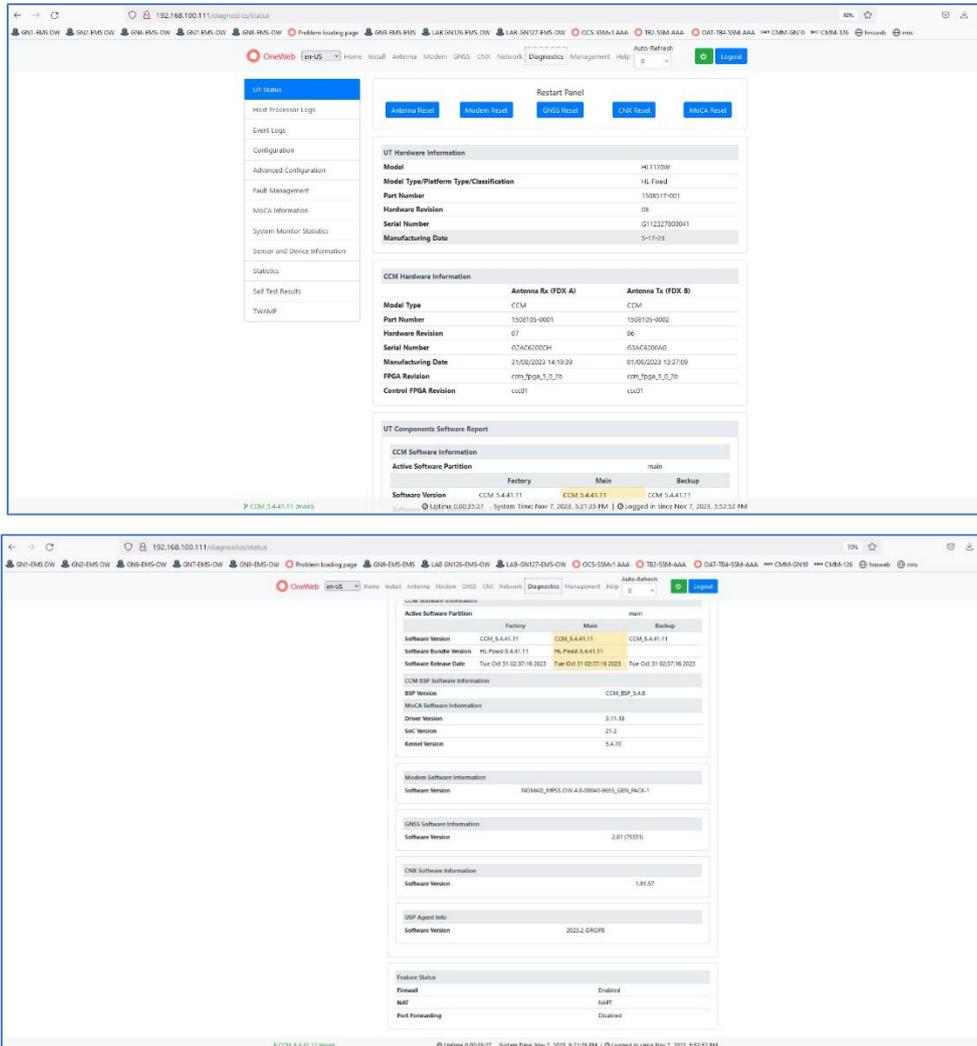
Login to the CCM LUI at <http://192.168.100.1>, and navigate to the *Diagnostics* → *UT Status* link to view the current software versions on the CCM /factory, /main and /backup partitions, Modem, OGR, and IDU (CNX-H):

Figure 6. HL1120-ODU, HL1120W-IDU Software Information
