**Document No.:** RB-250325-02  
**Date:** March 25, 2025  
**Classification:** External  
**Attn:** All OneWeb Customers  
**Related Products:** OW70L (SSMv2), OW70L (P-P), OW50SL, OW130L, OW50M, OW70M  
**Subject:** **OneWeb User Terminals Software Release Bulletin (2.0.6.1)**

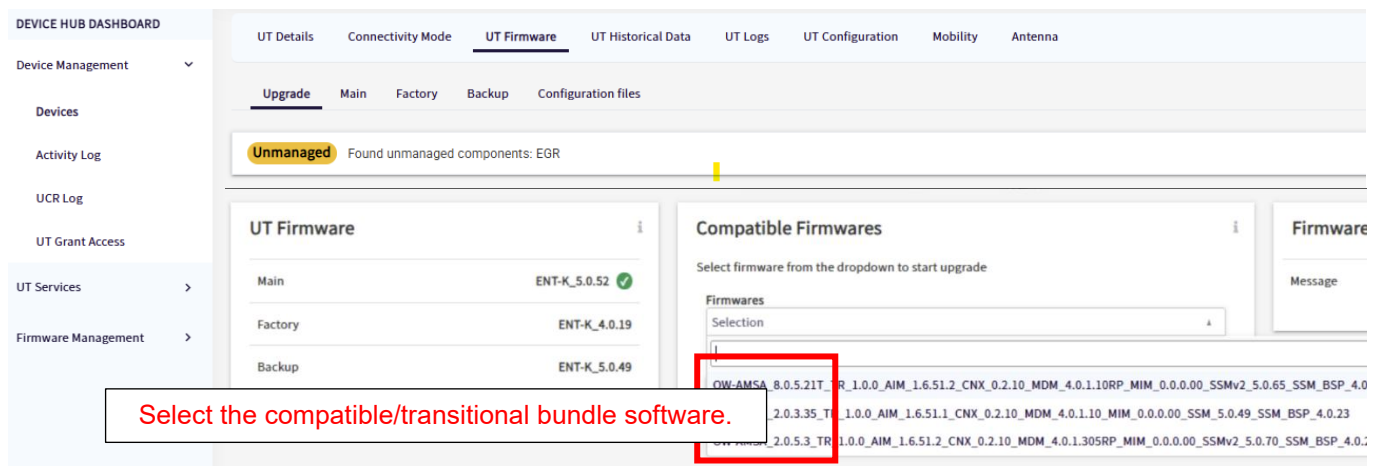
The Device Hub dashboard allows you to select the appropriate bundle software based on the UT firmware version and proceed with the upgrade.

Select the compatible/transitional bundle software.
