# Kymeta u8 Antenna Software Release Notes

FOR HAWK™ u8 LEO, PEREGRINE™ u8, and GOSHAWK™ u8 TERMINALS

700-00253-000 rev 18

Bundle version: KYMETA-A\_2.6.6.299

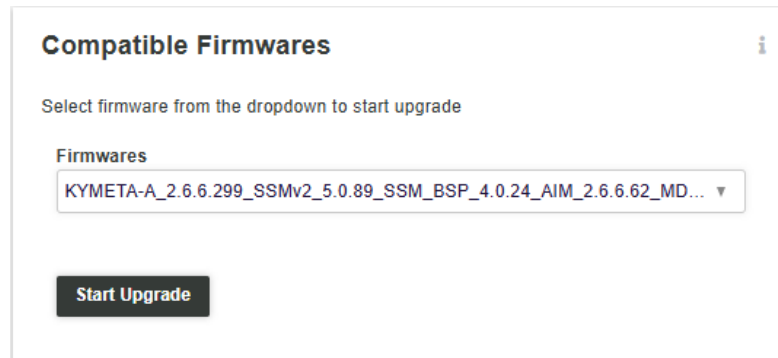
1. Ensure that your UT has a stable network connection and that the SSM LUI and Device Hub report the same software version.
2. Ensure that both the SSM LUI and Device Hub are in the main partition. If they are not, reboot the UT. If the result persists, contact support.
3. In Device Hub, navigate to **Device Management > Devices > UT Firmware > Upgrade** and select the update bundle (**2.6.6.299**), click **Start Upgrade**, and confirm when prompted.

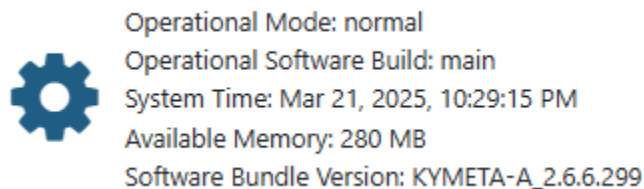
4. Verify the upgrade status is **Running**. The upgrade will take approximately 30 minutes to complete.
5. Wait 30 minutes and then refresh the page; ensure the status is now **“Successful”**.
6. In the SSM LUI, navigate to **Home** and verify that the **Software Bundle Version** is **2.6.6.299**.
